# Structural Audit of Sadhu Vaswani Pul using Institutionally Developed Displacement Sensors.

Mayuresh Raikwad, H.R. MagarPatil

**Abstract**— The main aim of this study is to conduct the structural audit of the Sadhu Vaswani Pul which is a Rail Over Bridge, situated in Koregaon Park, Pune and to establish the displacement sensors developed in the institution as a reliable test for structural auditing of the bridge decks. Traditional methods of auditing like the Rebound Hammer test and the Ultrasonic pulse velocity tests have been considered in this study. Very few methods are available for testing the deck displacement and this problem has been tackled here. The novelty of this research is that the institutionally developed displacement sensors are used for determining the deck displacement of the selected bridge. These sensors have not been used before and no on-site techniques are available to obtain the deck deflections under real-time loading. The displacement test on the decks was conducted. The critical decks which were determined during the Visual Inspections were tested by the displacement sensors. A two-axle truck of 18.5 tonnes was passed over the bridge deck and the di

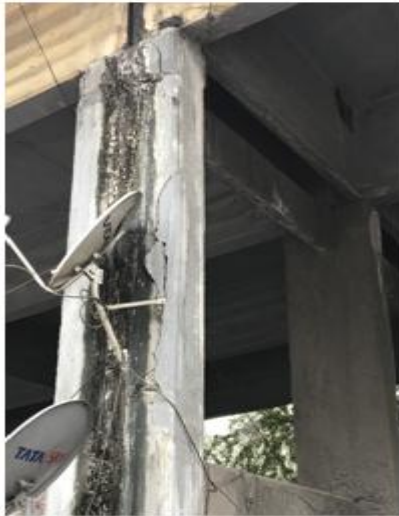
**Figure 1:- Cracks in column number 6A due to satellite dishes.**

This is due to non-uniformity in the material used during construction or the fact that proper construction practices might have not been implemented. Also, human settlements were seen below the bridge on the West side and since the columns of the bridge were used as supporting structures for the roofs built, the additional eccentric load was imposed on the columns. At several places, dish antennas were installed on the columns by drilling the antennas inside the column

without taking into account the reinforcement damage and thus further loss of strength of the column can be noted.

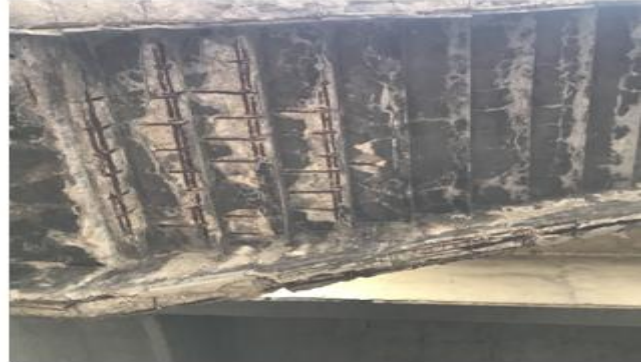
Decks with exposed reinforcements were seen at many places and also the staircases with totally open reinforcement were observed. The staircases were asked to be closed immediately as their condition was worse. Horizontal cracks were also observed on the decks and severe damage at the top of the column with structural cracks were also seen as shown in Figure 2.

**Figure 2. Exposed reinforcement on the underside of the staircase.**

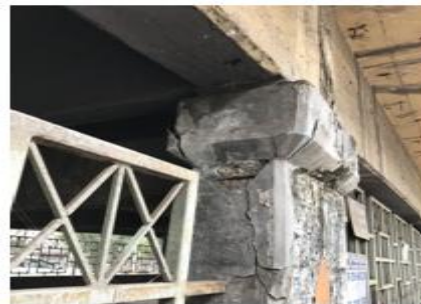
The horizontal cracks spanned over the total length of the deck. The underside of the deck showed growth of algae which led to the assumption that water leakage and seepage were occurring thereby accelerating the corrosion process. The beam girders present below shows small cracks. The columns also shows many vertical cracks spanning over the entire length of the column, pointed out in Figure Number 3. This drilling was done without proper consideration of the damage to the column structure and the reinforcement that lies under as visible in Figure 1. While observing the above side of the deck it was noted that bitumen was just sprayed over the expansion joints as prevention for leakage of water but since the proper process was not adopted the leakage continued and thus the growth of algae was justified.

**Figure 3. Structural cracks were seen on the columns**

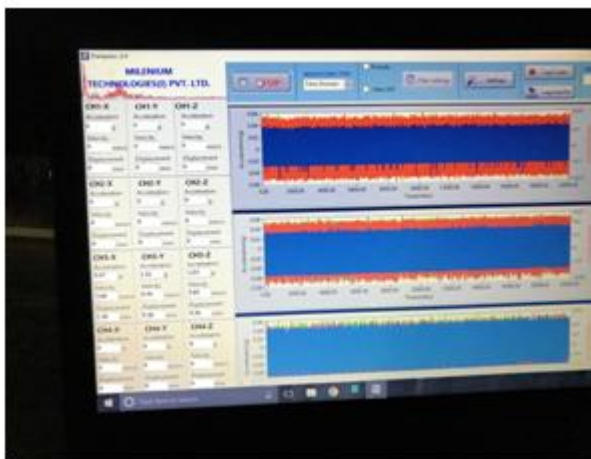
Thus from the above Table number VII, it is clear that the maximum value of displacement is 37.33mm or 0.12 feet. Since this value and all the other values of displacement in the Y direction are way less than the expected limit according to AASTHO-IFRD, it can be concluded that the decks are safe. The bridge was 25 years old and thus the minimum deflections suggest that the severe damages to the decks have not occurred. The bridge did not have any bearings present below the decks and the vibrations felt can be a result from the absence of bearings. Thus proper deck treatment or replacement and installation of bearings should be conducted to avoid further damage. The vibrations might lead to an increase in spacing between the expansion joints, causing an improper transfer of load to the columns, seepage of water to the internal portions leading to corrosion and thus causing serious problems which will be economically challenging and time-consuming. The positive results obtained from the test help to establish the fact that this method can be used on the site for deck displacements. Thus this method can be used for auditing the bridge decks or the other components of the bridge where the deflections or displacements occur. The compressive strength of the selected columns is mentioned in the Table number VIII and Table number IX. These indices are the average of the six readings taken beforehand. From the Rebound number vs Compressive strength graph, the compressive strengths of the columns are found and tabulated. The column Number 1 on the East side is the column with the maximum height of 6meters.

**FIGURE 11 . DISPLACEMENT READINGS FOR DECK NUMBER 7.**
