# Structural Audit of Sadhu Vaswani Pul using Institutionally Developed Displacement Sensors.

Mayuresh Raikwad, H.R. MagarPatil

**Abstract**— The main aim of this study is to conduct the structural audit of the Sadhu Vaswani Pul which is a Rail Over Bridge, situated in Koregaon Park, Pune and to establish the displacement sensors developed in the institution as a reliable test for structural auditing of the bridge decks. Traditional methods of auditing like the Rebound Hammer test and the Ultrasonic pulse velocity tests have been considered in this study. Very few methods are available for testing the deck displacement and this problem has been tackled here. The novelty of this research is that the institutionally developed displacement sensors are used for determining the deck displacement of the selected bridge. These sensors have not been used before and no on-site techniques are available to obtain the deck deflections under real-time loading. The displacement test on the decks was conducted. The critical decks which were determined during the Visual Inspections were tested by the displacement sensors. A two-axle truck of 18.5 tonnes was passed over the bridge deck and the di

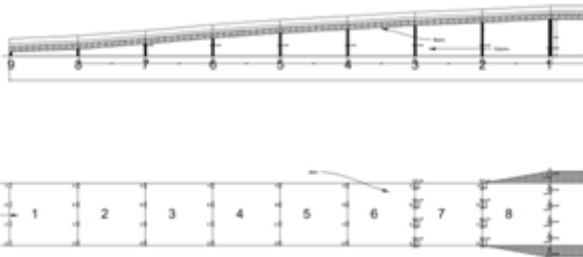
Figure 9. Plan of the bridge on West Side.

Rebound hammer test was carried out on the columns which were claimed to be critical. The columns selected for testing were column numbers 1A, 1B, 1C, 1D, 1E, 1F, 5A, 5B, 5C, 5D, 6A, 6B, 6C and 6D from the East side and column numbers 3A, 3B, 3C, 3D, 4A, 4B, 4C, 4D, 9A, 9B, 9C and 9D from the West side of the bridge. These can be seen in Figure 9.
